Selected Al Alloy and Analyses of its Decrease Machinability

Kusmierczak, Sylvia¹, Naprstkova, Natasa²

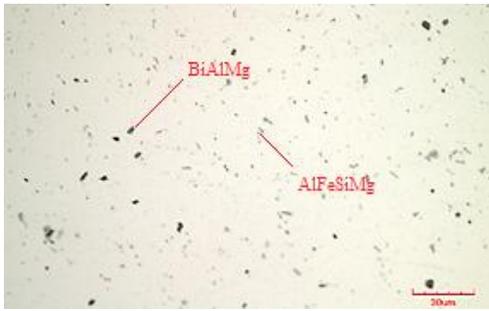
Fig. 3 Sample OK, cross section

First, the structure was analyzed in unetched condition. Samples were analyzed by light microscope Olympus LEXT OLS 3100. [8, 9] For samples OK (Fig. 3) we could observe uneven distribution of phases α and intermetallic phases. In cross section was possible to observe two types of phases that differed in size. Larger particles were intermetallic phases of the type BiAlMg, which have a positive effect on the machinability due to the low melting point of Bi. Furthermore, there were the polycomponent phases containing most of the alloying elements. These were the phases based on AlFeSiMg. In sample NOK in cross section we could observe uneven distribution of different phases (Fig. 4). In comparison with the sample OK the structure contained a smaller proportion of larger phases based on BiAlMg. Large particles were intermetallic phases AlBiMg, wherein the proportion of Bi in this phase was lower than the proportion in sample OK. Because the incidence and distribution of those phases significantly affect machinability alloys, it could be assumed that the smaller quantity of these had influence on the formation and in particular on the shape of the chip. Further, in the sample NOK there found the intermetallic phases AlPbMg. These were small particles of about 2 μm . In sample NOK there was also possible to observe complex polycomponent phases with representation of most alloying elements. These were the phases based on AlFeSiMgMnPbCu. In samples NOK there found a smaller number of phases based on BiAlMg, it could be assumed that for this reason, this alloy will have a worse machinability than the sample OK. In sample OK in longitudinal section there were observed directed intermetallic phases in the forming direction (Fig. 5). In the Fig. 6 were a longitudinal sectional structure of the sample NOK. When comparing a sample OK and NOK in longitudinal section, there could be observed diversity in the size of intermetallic phases. In sample OK could be observed large intermetallic phases, which were uniformly spaced and were approximately 50 μm . In sample NOK, the phases were smaller and irregularly distributed. Their size was about 30 μm .

When comparing a sample OK and NOK after microscopic analyses using light microscopy in longitudinal section, there can be observed diversity in the size of intermetallic phases. In sample OK can be observed large intermetallic phases, which are uniformly spaced and are approximately 50 μm . In sample NOK, the phases are smaller and irregularly distributed. Their size was about 30 μm .

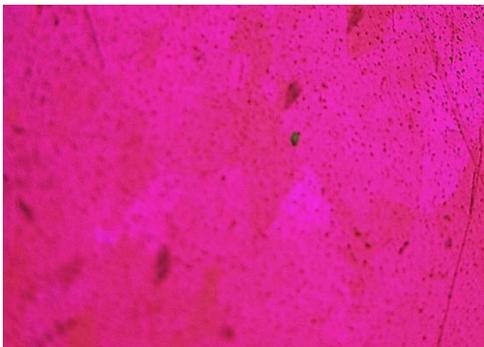
Fig. 7 Sample OK, mgn. 100x

Further, an analysis of the microscopic structure was realized in etched state. This analysis was performed in order to investigate grain size. Samples of material were etching by mixtures of acids and observed in polarized light with a light microscope Olympus BX51M. See Fig. 7 and Fig. 8.[10]

When comparing the grain size on samples (etched state) OK and NOK there was possible to observe the difference in grain size. In sample OK could be observed finer grains than in sample NOK. Because the grain size also affects the machinability of aluminum alloys may be assumed that the sample OK is better machinable.

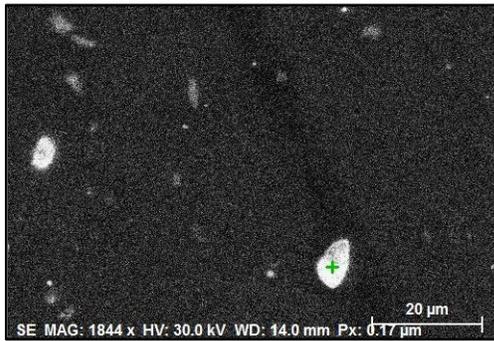
Fig. 9 Particle 2, sample OK

In sample OK was analyzed three particles. Fig. 9 shows one of them. In sample NOK were analyzed four particles. Fig. 10 shows one of them. For the first particle, according to the chemical composition it has been possible to say that this was an intermetallic phase based on AlPbMg. The size of the first particles was approximately 4 μm. The second analyzed particle was identified as an intermetallic phase based on AlBiMg. This particle was also great about 4 μm. Third particle had a similar chemical composition as

the second particle. This was according to analysis the intermetallic phase based on AlBiMg. The difference, however, was on its size. This particle was approximately half the size, was great about 2 μm .

According to the results of EDX analysis, for sample OK, there was an intermetallic phase based on BiAlMg with major share of Bi. Oxygen and carbon in this particle found as impurities. Due to the large proportion of Bi we can say that these particles could have a significant positive effect on the machinability of this alloy. The size of this particle was about 10 μm . The second analyzed particle being by chemical composition, size and shape similar to the first particle but there had a higher proportion of Bi. The size of this particle was also about 10 μm . The third particle was by EDX analysis characterized as polycomponent phases based on AlFeSiMg. In sample NOK were analyzed four particles. For the first particle, according to the chemical composition it has been possible to say that this is an intermetallic phase based on AlPbMg. The size of the first particles was approximately 4 μm . The second analyzed particle was identified as an intermetallic phase based on AlBiMg. This particle was also great about 4 μm . Third particle had a similar chemical composition as the second particle. This was according to

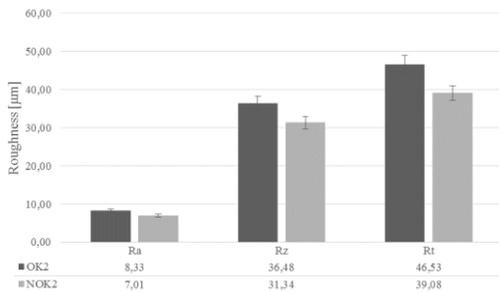
Fig. 11 Comparison of surface roughness for samples OK2 and NOK2 – roughing

Next was evaluated the obtained surface roughness Ra, Rz and Rt after machining, how was mentioned above. Fig. 11 and 12 show examples of created graphs. During roughing roughness was slightly better for the alloy NOK, when finish machining the surface roughness were either the same or slightly better for the alloy OK.[13, 14]

Next samples were machining. For roughing the roughness was slightly better for the alloy NOK, when finishing the surface roughness was either the same or slightly better for the alloy OK.

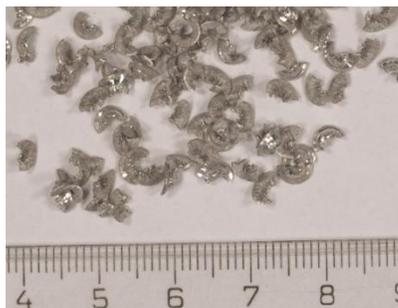
Fig. 13 Chips OK1, roughing

There were also evaluated chips which were obtained by machining under cutting conditions. Chip was evaluated visually, next according to the quantity of chips per 100 g and according to the stamping chips coefficient. Fig. 13 and 14 show samples of the chips after the machining alloys OK and NOK. Evaluation according to the number of chips per 100 g according to the company's internal process was carried out in a laboratory balance AND GF-200, which is measured with an accuracy of 0.001 g. Fig. 15 and 16 show graphs obtained by measurements. [15]

The chip for OK and NOK was always small, crumbly, arched. There were observed only small differences in the size of the chip for each cutting conditions.

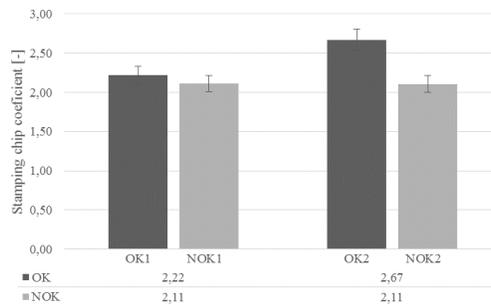
Fig. 17 Comparison of stamping chip coefficient for samples OK and NOK

Another measurement was the determining stamping chips coefficient. This has been implemented only for the roughing operations, because the finish machining originated chip which was difficult to measure. Fig. 17 shows graph with obtained results.

For stamping chip coefficient was followed that during both cutting speeds occurred in samples OK to higher stamping chip, thus a higher plastic deformation of the chips.

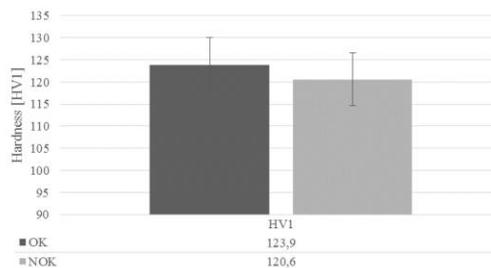
Fig. 18 Comparison of hardness for the samples OK and NOK

The next measurements carried out in the evaluation irons OK and NOK were hardness measurements. Hardness test was chosen Vickers according to ČSN EN ISO 6507-1. Sample surface was ground and then polished. Was carried out ten measurements for each sample. The places of individual stitches were chosen randomly. The measured values are shown in the graph in Fig. 18.

The difference in hardness values may be stated due to lower copper content in sample NOK. The hardness difference between samples was insignificant and therefore it would not have a significant effect on machinability of both samples OK and NOK.

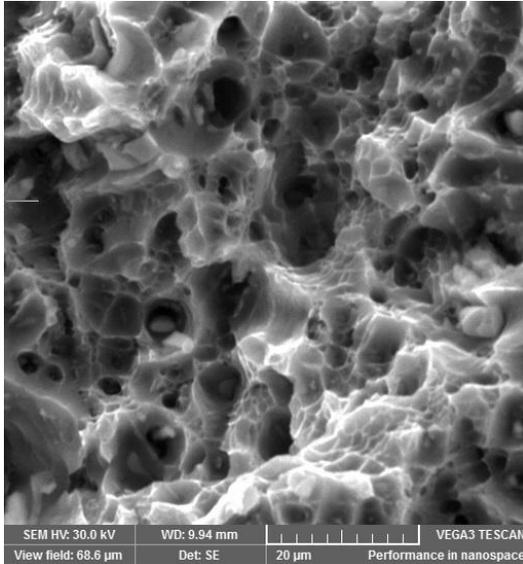
Fig. 19 Sample OK

For fractographic analyses were made samples from rods OK and NOK. On the experimental samples was created notch and with using tensile test machine these samples were broke. The fracture surface was formed under the same conditions for the sample OK and NOK. Then the samples were observed on electron microscope Tescan Vega 3. On the Fig. 19 and 20 there are pictures of fracture surface for both samples. [16]

On the base of fractographic analysis may be stated that it was a breach of ductile pit morphology For both, OK and NOK, in fractures there were particles of various sizes, on the sample OK, however, they were larger. For both samples particles were cohesively connected with the matrix, the matrix was during the loading in the area of occurrence of particles considerably plastically deformed. For samples there was not brittle failure of particles. On the fracture surfaces were observed defects of metallurgical origin (oxide films, porosity) that when loading to initiate the formation of cracks.
